The sickening feeling that results immediately after kerbing an 'R-performance' BBS wheel is not nice, and neither is the cost of replacement. Fortunately, repair is possible

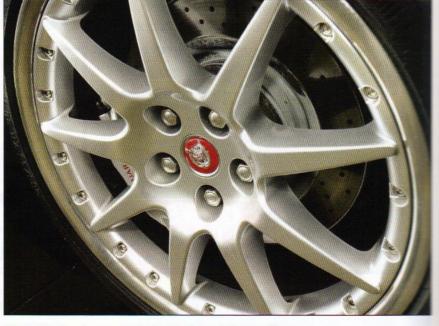
The air valve is cleverly hidden below a hollow bolt; this toolkit contains an inflator adaptor, blanking plug removal tool and spare plugs
